Glass Balustrade Load Testing Report	
Report Number:	STS13-0071-07
Client:	The Glass Outlet
Client Contact:	Mr. Richard Van Lieshout & Mr. Luke Keong
Job Description:	The Overload Testing of Glass Balustrade Assembly
Specifications:	<p>'Summit' Nano Top Glaze Frameless Balustrade with Madrid Spigots <u>Glass Panel (3 off)</u> Width: 900mm Height: 970mm Thickness: 12mm "HEAT SOAKED Toughened Glass" <u>Spigots (2 off)</u> Type: Madrid Spigot (MAD-SBP-P) Material: 2205 Stainless Steel <u>Hand Rail (1 off)</u> Section: 25mm x 21mm x 1.2mm Material: 2205 Stainless Steel Adhesive: Fuller – HBF 660</p>
Test Standard:	Clients Requirements
Engineering Review:	Noel F Straker <i>BEng, MEngSc, CPEng, NPER, RPEQ 10652</i> Signed:

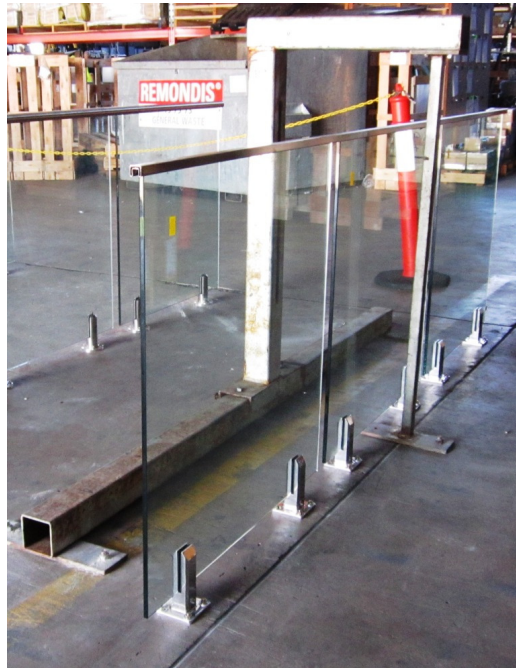
Photo 1 Balustrade Assembly

The balustrade was assembled and fixed to the floor of the Glass Outlet Warehouse with 10mm x 65mm Dyna bolts. The Hand Rail was attached to the top of the glass with Fuller – HBF 660 Adhesive (Refer Photo 1)

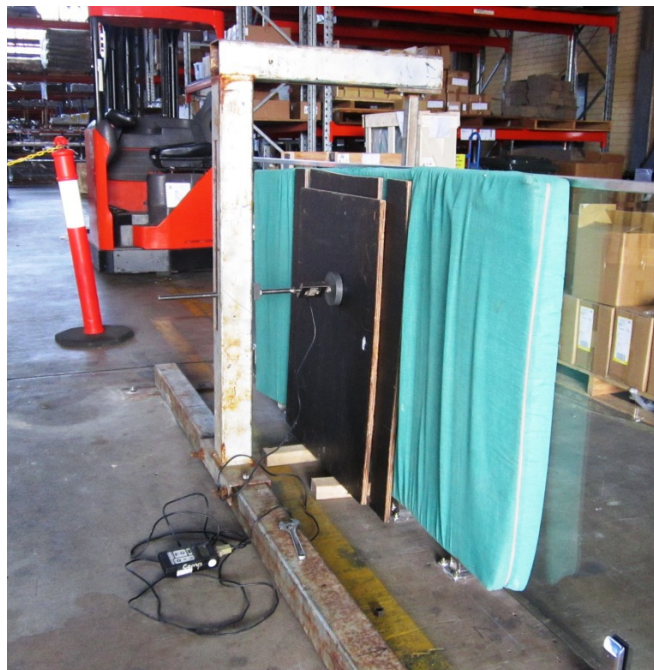
Photo 2 Test Method

A rigid timber sheet and foam underlay was placed across the front face of the center panel to produce a uniformly distributed load. The load was applied horizontally to the center of the panel. The load was applied with a mechanical advantage thread system. The load was monitored with a calibrated load cell. The load was increased until the Balustrade assembly was unable to sustain the applied load. At the completion of the loading the balustrade assembly was inspected for any signs of failure. (Refer Photo 2)
